REMIEDIATING SUBSIDING FARM INFRASTRUCTURE

REMEDIATING SUBSIDING FARM INFRASTRUCTURE

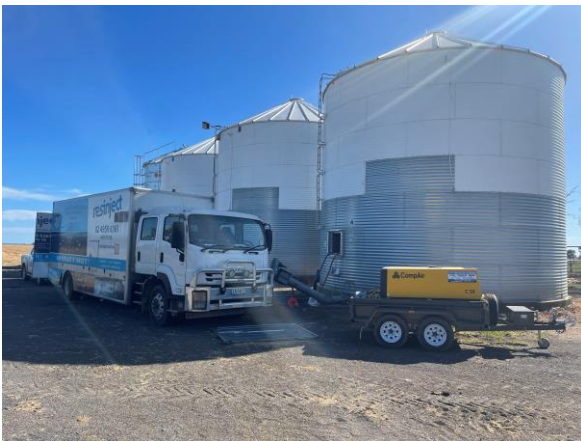
Figure 1. The Resinject Rig outside the three large grain silos

The three large grain silos were built on raft slabs. The subsidence beneath the foundations was likely due to long term settlement. Similarly, the subsidence beneath the rear verandah slab was likely due to the gradual sinking of the ground over an extended period of time.

Resinject's Structural Consultant attended the site for an inspection and measured up to 94mm subsidence from original levels in some areas of the silo slabs, up to 48mm of subsidence on the verandah slab, and up to 24mm of subsidence on the wash bay slab. This subsidence was suspected to be the primary cause for the concrete cracking in all three cases.

To remedy the subsidence beneath the silos, Resinject proposed to treat the approximate 90 lineal metres with their specialised Resinject RSJ170 solution. The plan was to initially “underseal” the affected area by injecting the resin solution directly beneath the slabs at various points across the area. It was then proposed that a series of deeper injection points be conducted to confirm consolidation and stabilisation and improve the structural integrity of the soils below the slabs. The final stage was to slab-jack the internal area of the slab to confirm the achievement of the ground’s consolidation, installing of robust support, fill existing voids, and gain the required lift for realignment.

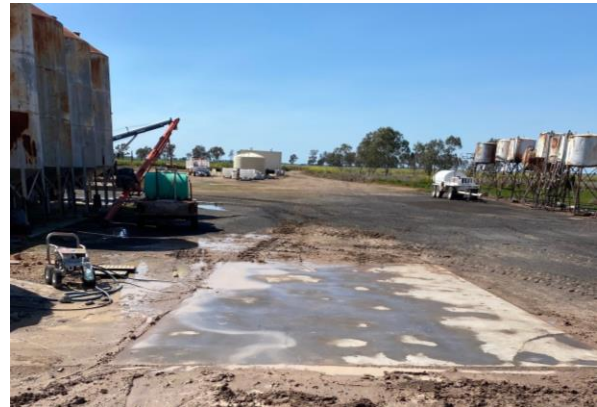
The cause of subsidence beneath the 6m x 6m concrete slab wash bay was suspected to have been caused by inadequate subsurface drainage,

stormwater drainage and the high clay content of the soil.

Figure 2. The concrete slab acting as a vehicle wash bay

To remedy the subsidence beneath the verandah and the wash bay, Resinject proposed to improve load-bearing capacity and minimise future movement by treating the area with Resinject RSJ170. An initial ‘underseal’ would be conducted through a series of injection points to strengthen and improve the existing ground beneath the slab. A slab-jacking method followed to the internal area of the slab to confirm consolidation and support, void-fill, and gain the lift required to realign the slabs.

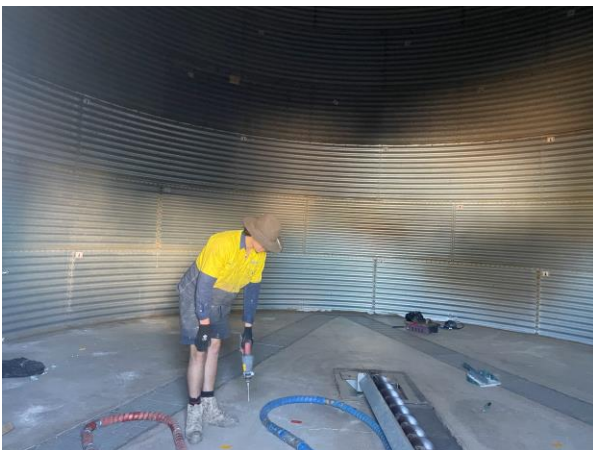
Figure 3. Resin injection process inside a grain silo

The resin injection methodology effectively raised the concrete slabs, filled the underlying voids, compacted the foundations, and installed stabilising piers to ensure a robust and enduring support structure remained for the future heavy loading.

All of this was completed through a pattern of small diameter drill holes through the concrete base slabs, which were re-filled with non-shrink grout upon completion of the resin injection works.
